**Contract No. ND/2019/02**

**Kwu Tung North New Development Area, Phase 1:  
Road and Drains between Kwu Tung North New  
Development Area and Shek Wu Hui**

**Baseline Condition Survey and  
Baseline Vibration Impact Assessment Report**

Rev. 7

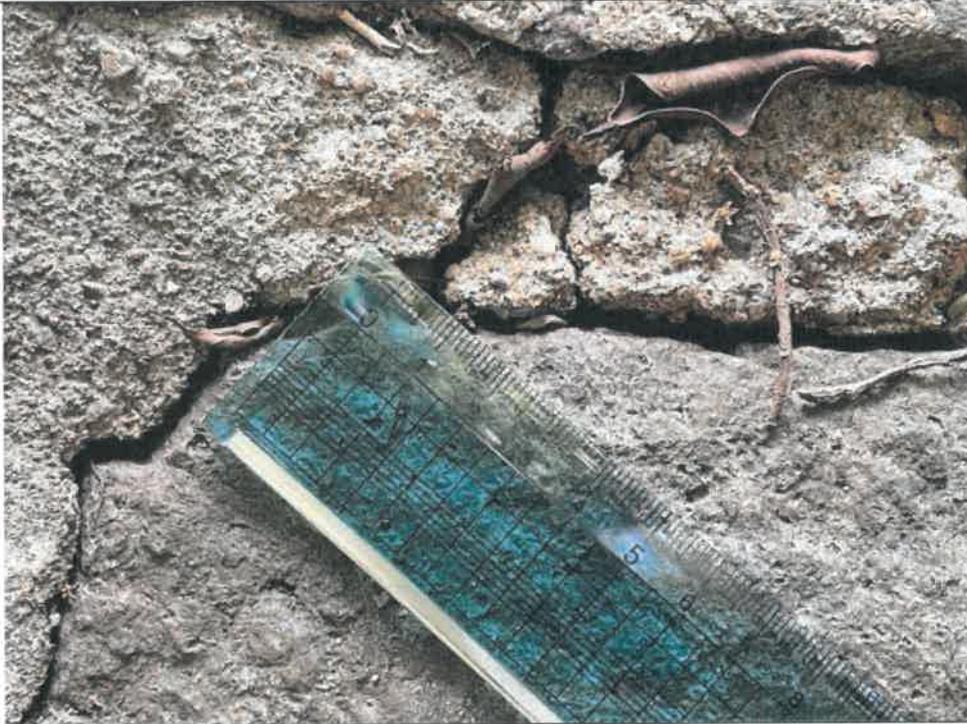
Photo : G202-11 Wide Crack on Surface

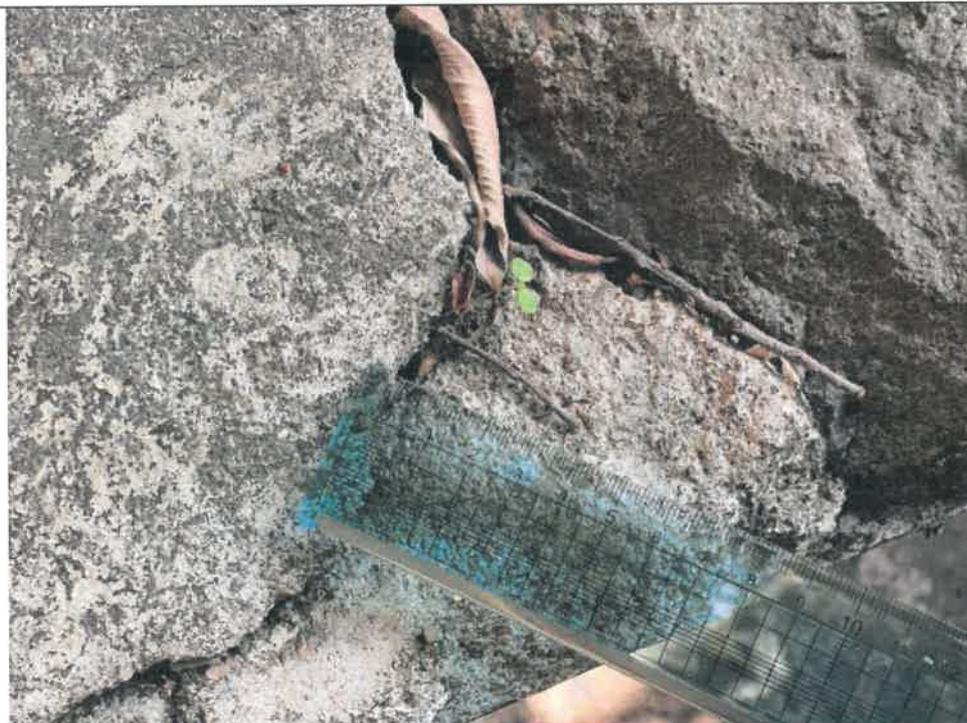
Photo : G202-12 Wide Crack on Surface

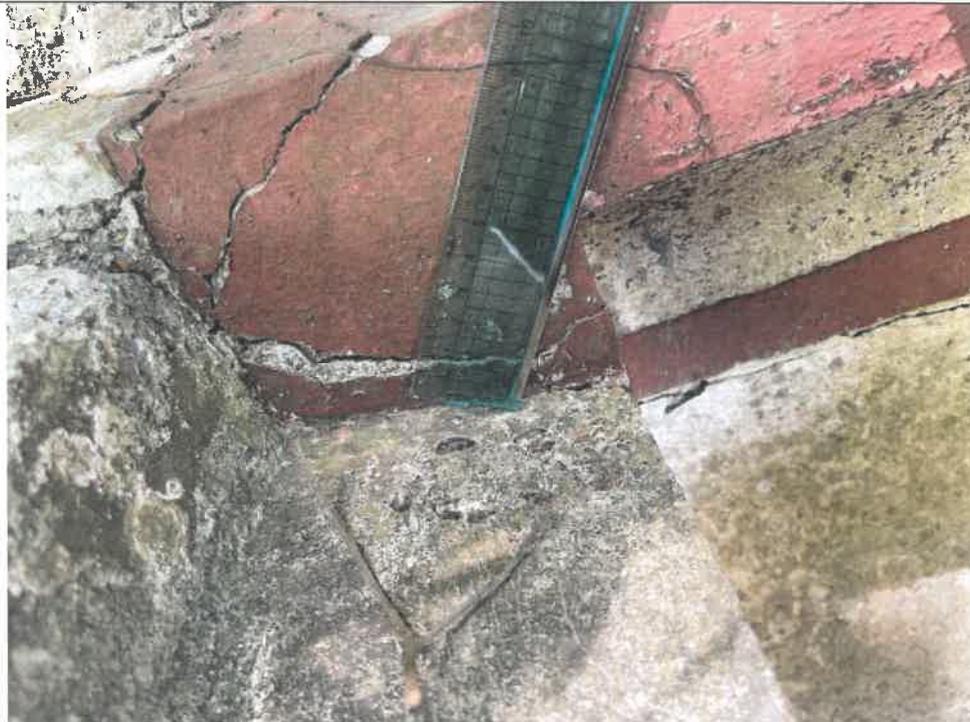
Photo : G202-13 Wide Crack on Surface

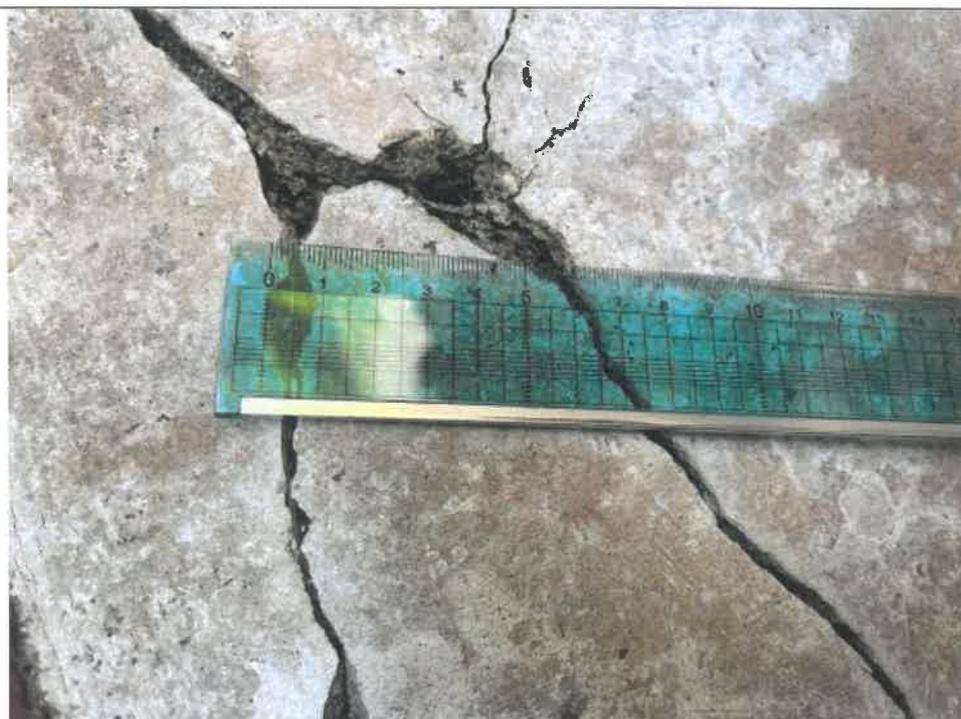
Photo : G202-14 Wide Crack on Surface

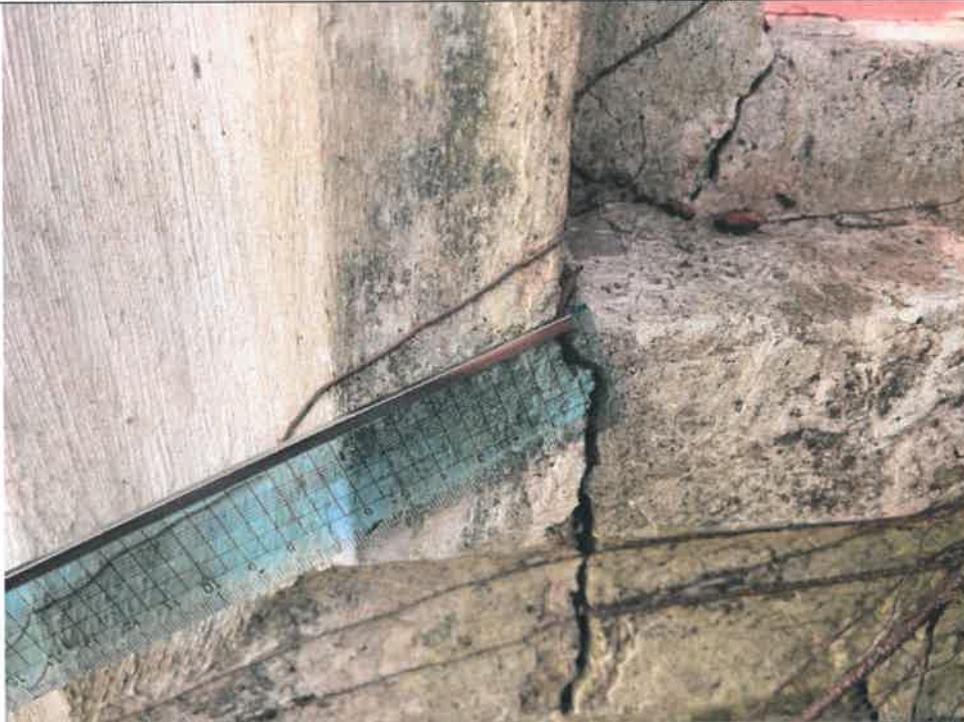
Photo : G202-15 Wide Crack on Surface

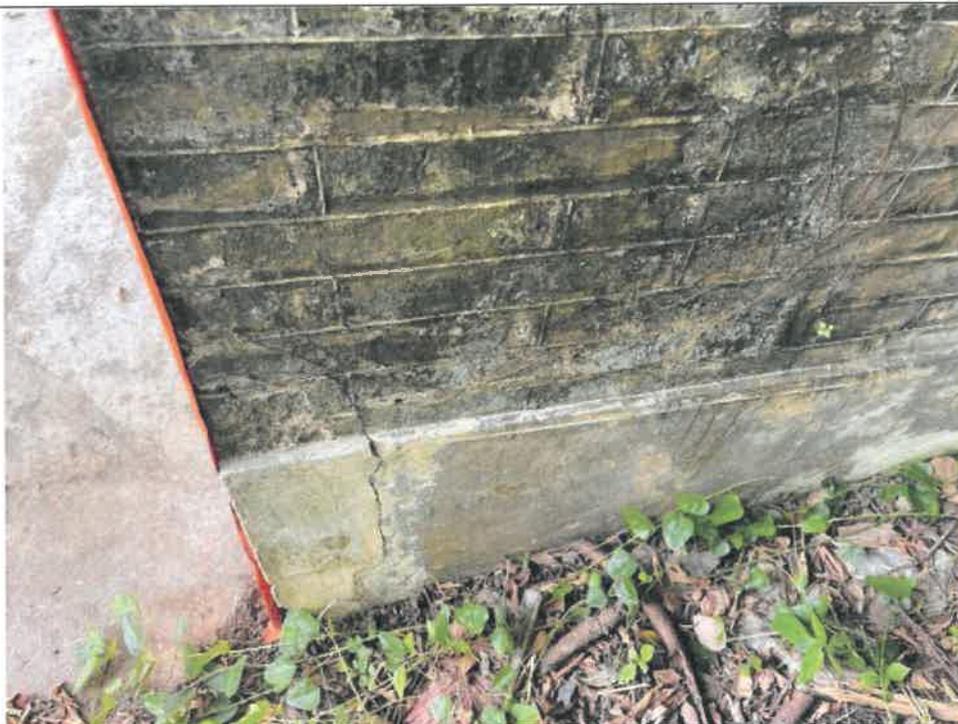
Photo : G202-16 Fine Crack on Surface

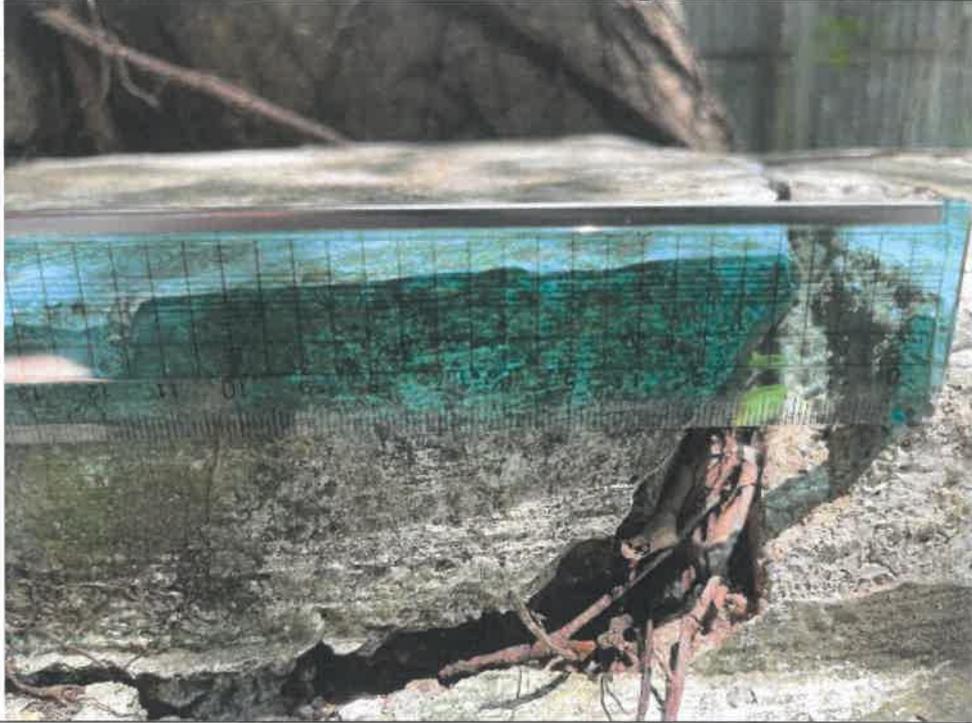
Photo : G202-17 Wide Crack on Surface

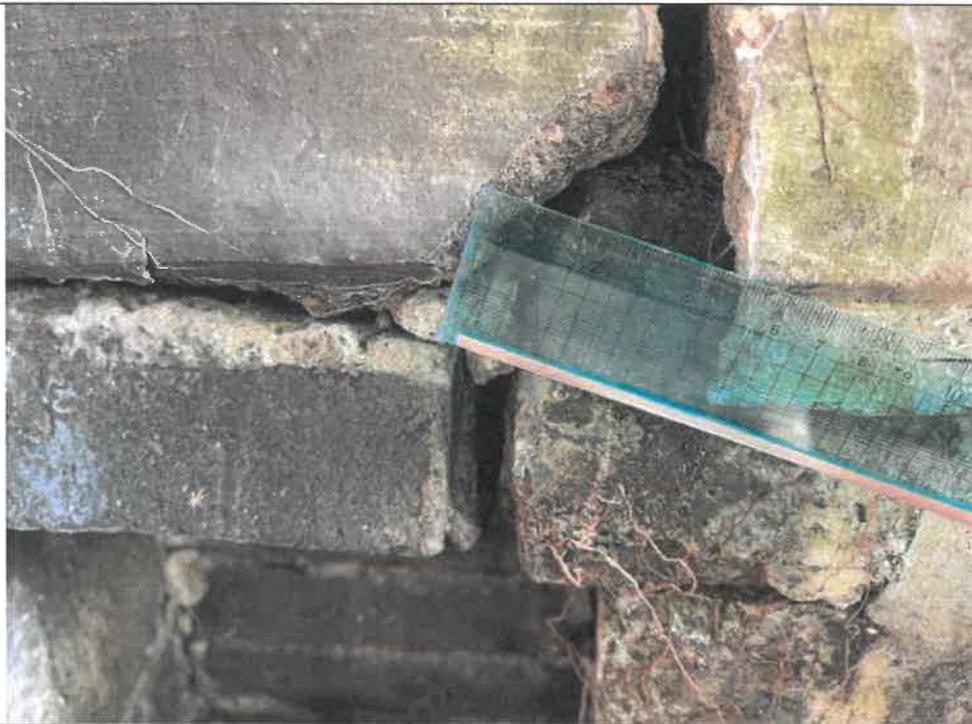
Photo : G202-18 Wide Crack on Surface

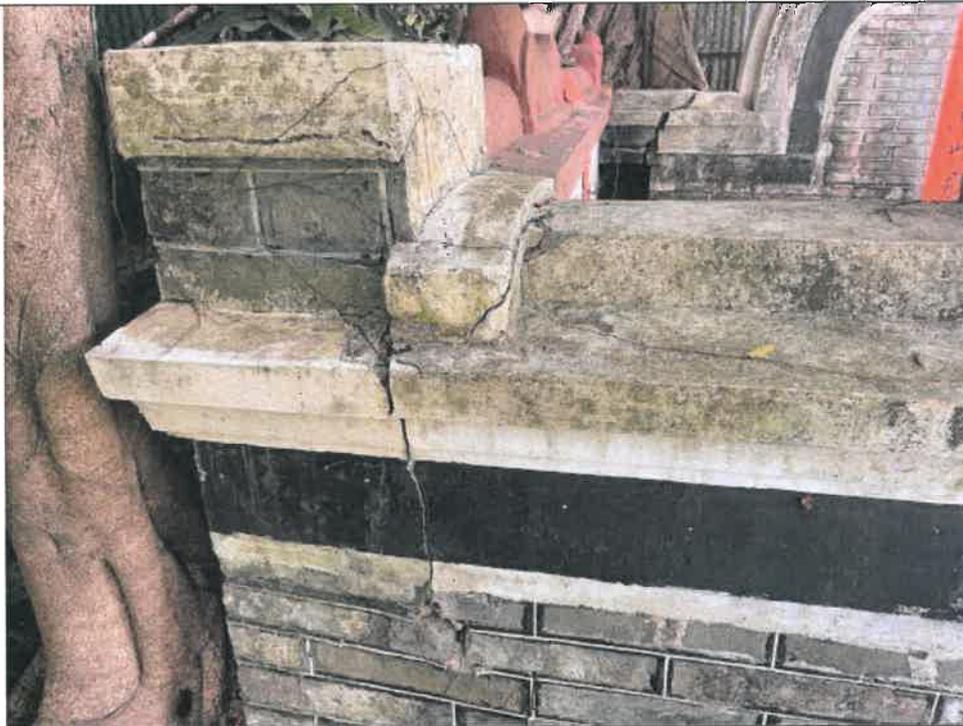
Photo : G202-19 Moderate Crack on Surface

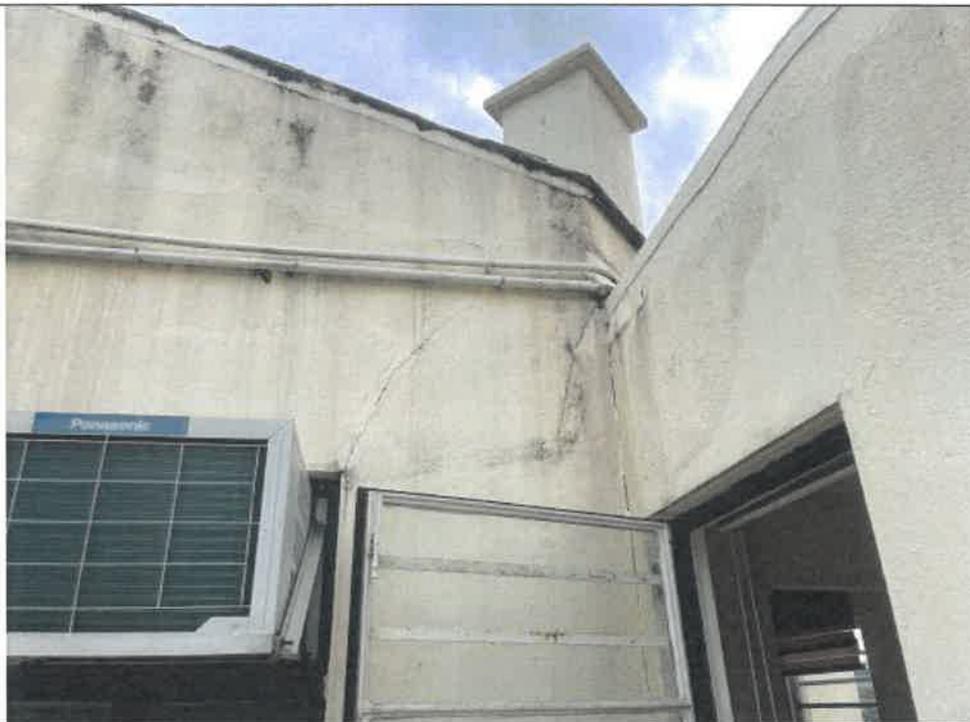
Photo: G303-34: Fine Crack on Surface

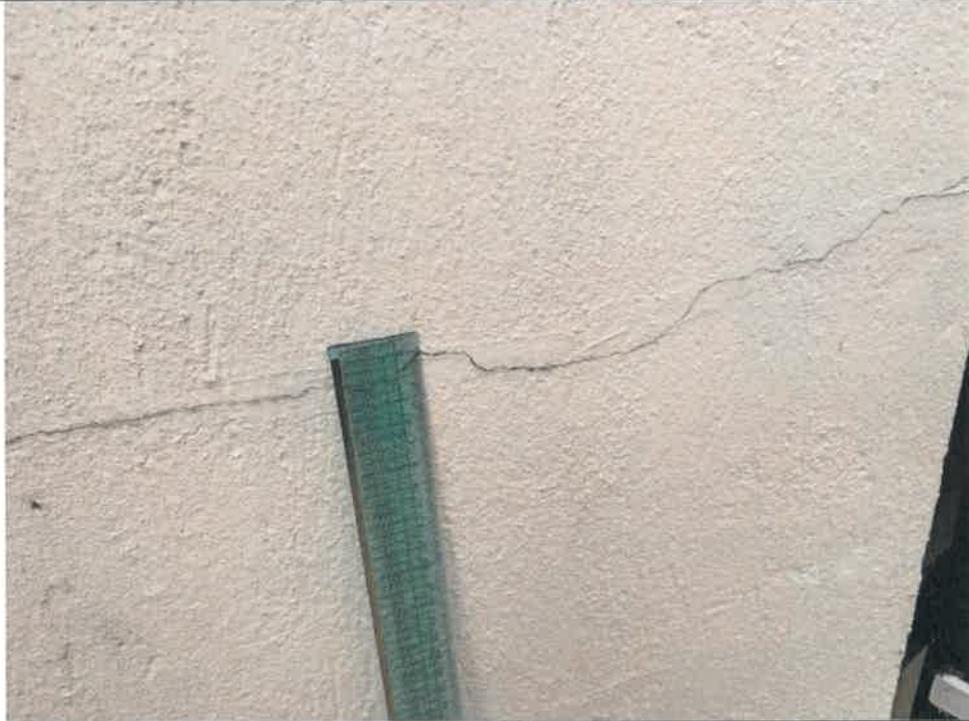
Photo: G303-35: Fine Crack on Surface

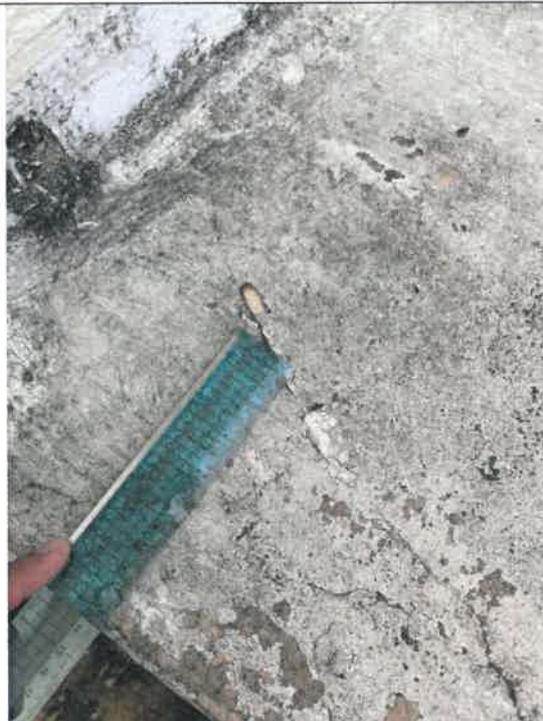
Photo: G303-36: Fine Crack on Surface

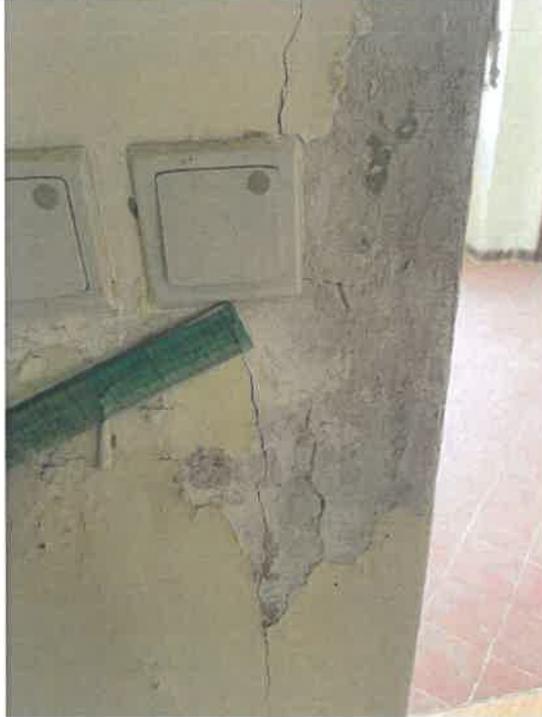
Photo: G303-37: Fine Crack on Surface

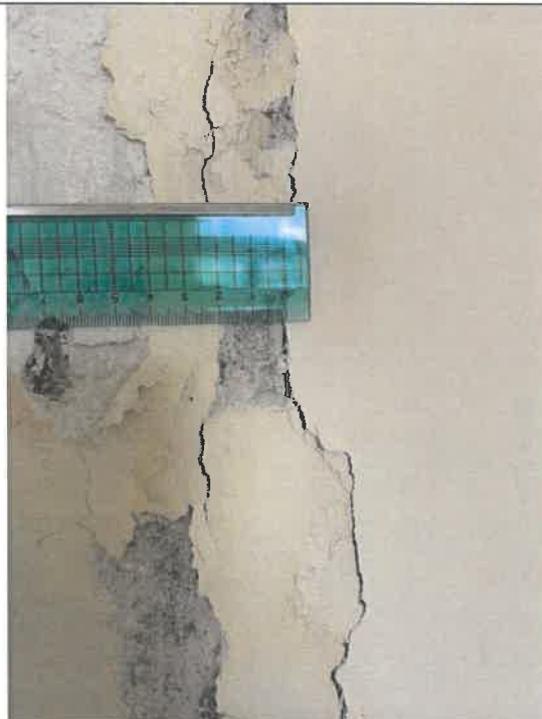
Photo: G303-38: Fine Crack on Surface

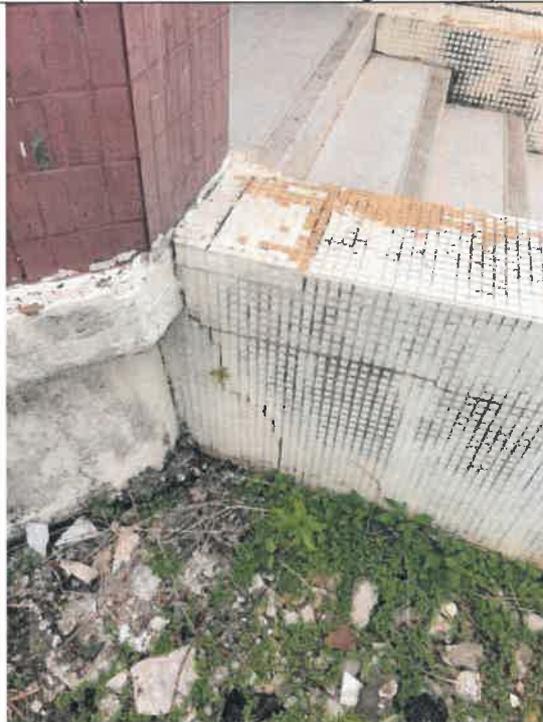
Photo: G303-39: Moderate Crack on Surface

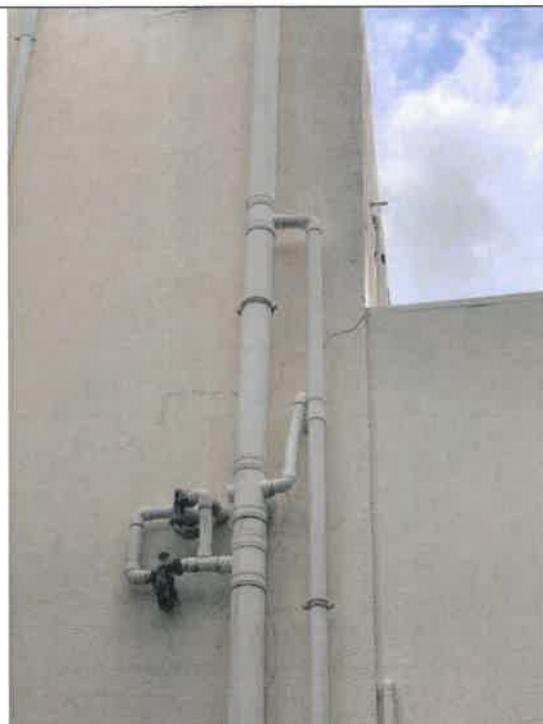
Photo: G303-40: Moderate Crack on Surface

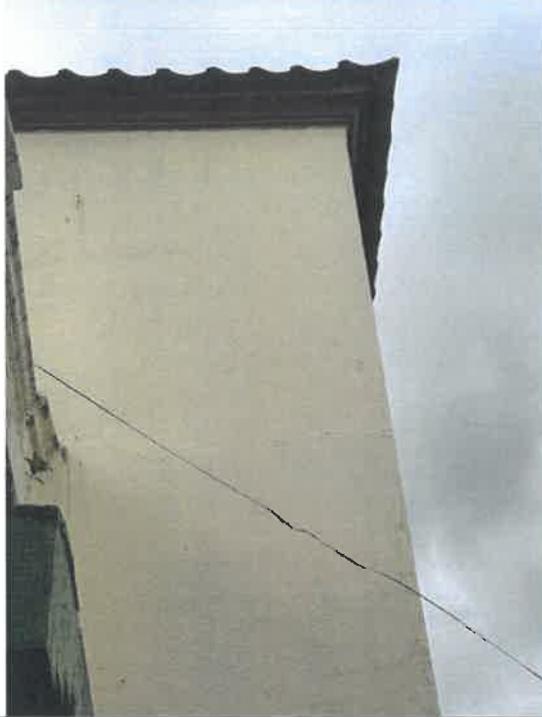
Photo: G303-41: Fine Crack on Surface

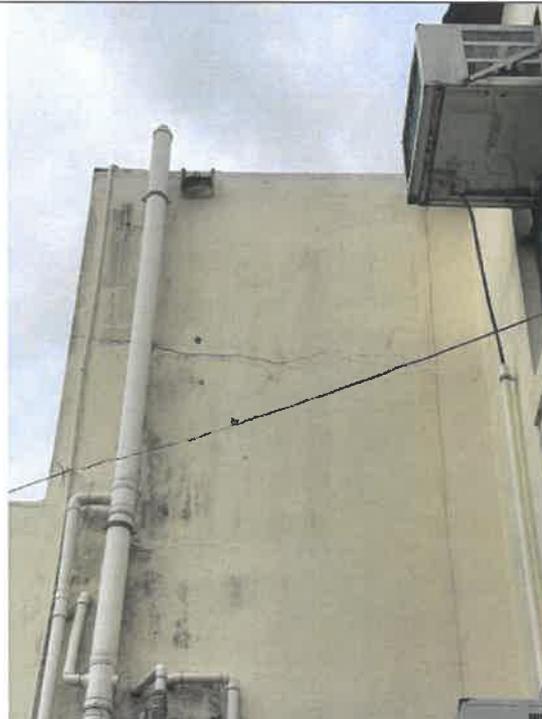
Photo: G303-42: Moderate Crack on Surface

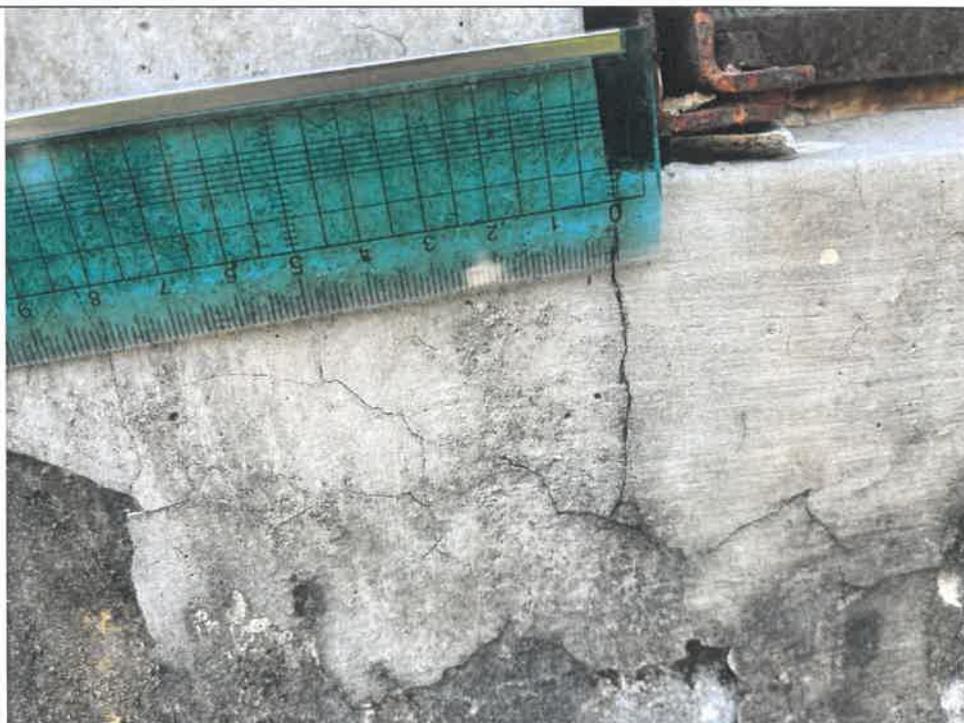
Photo G308-28: Moderate Crack

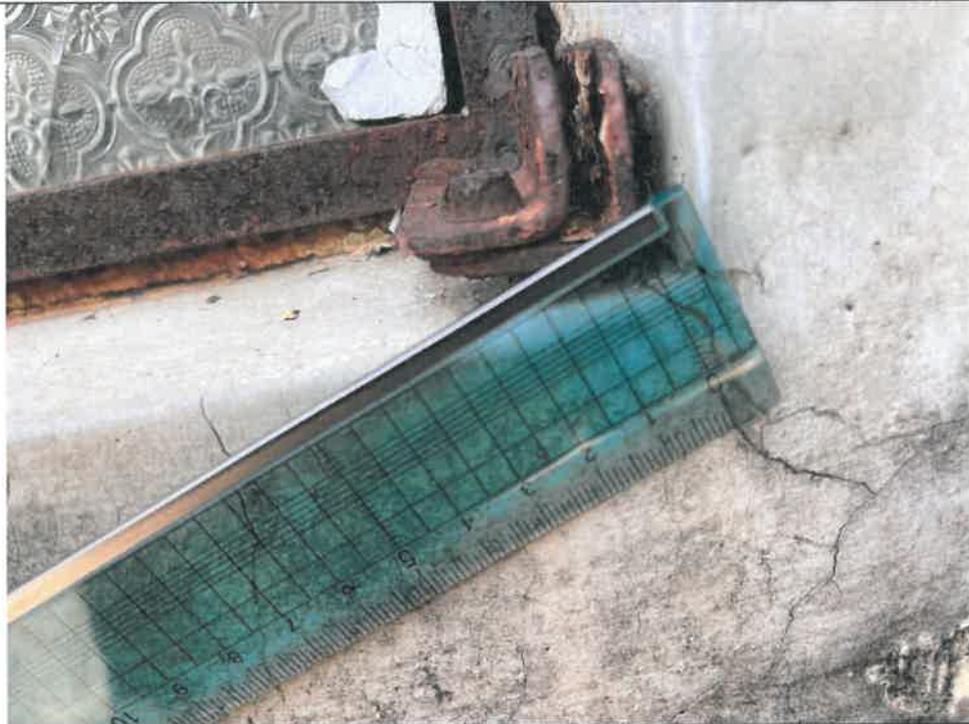
Photo G308-29: Moderate Crack

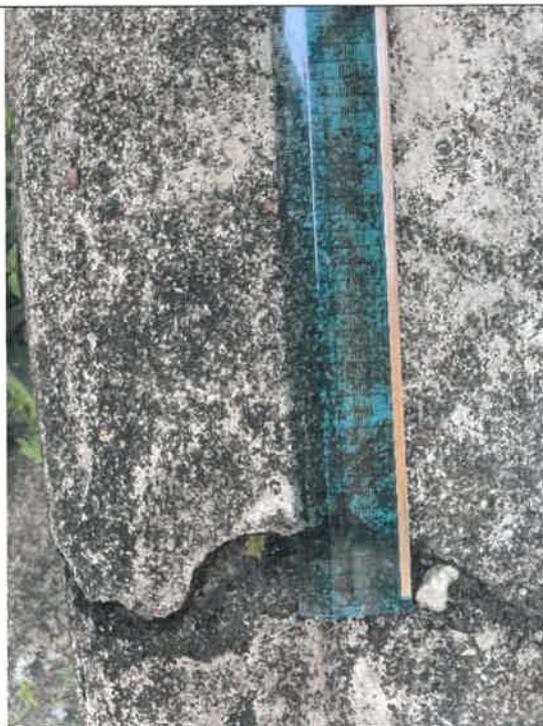
Photo G308-30: Wide Crack

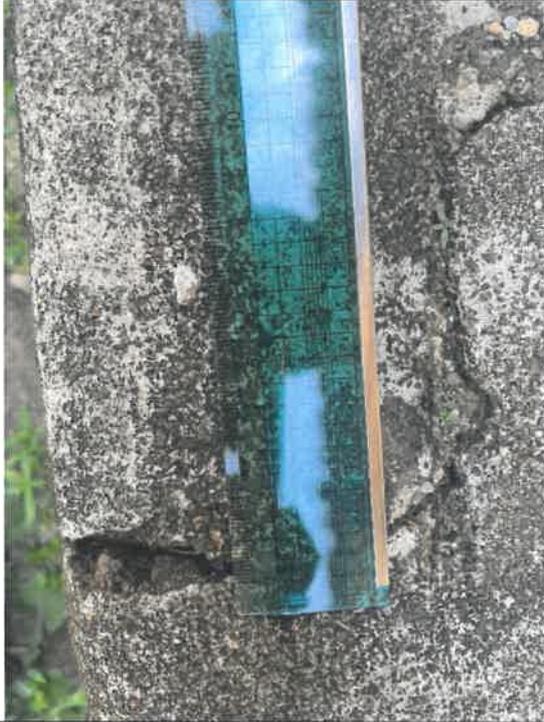
Photo G308-31: Wide Crack

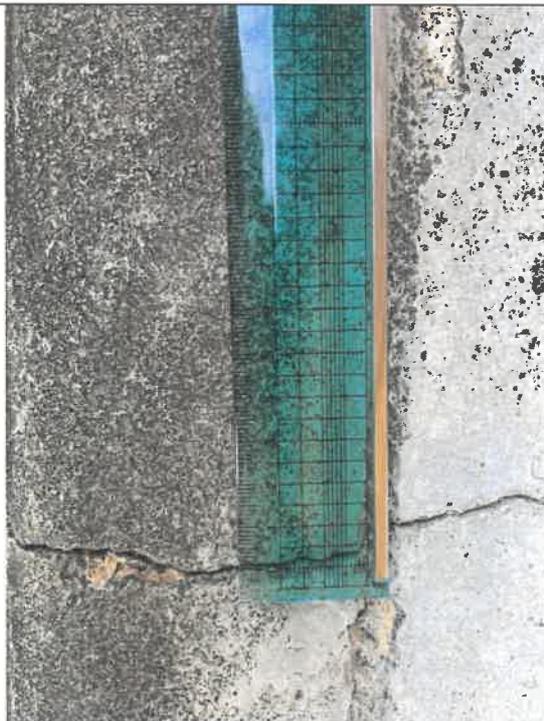
Photo G308-32: Wide Crack

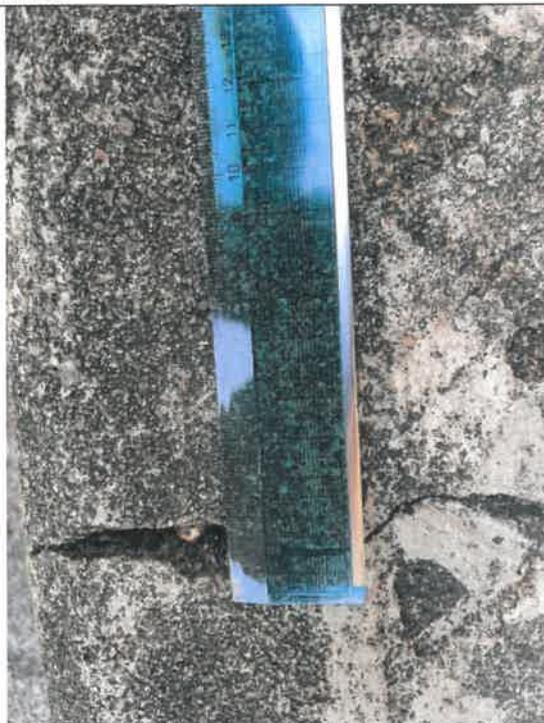
Photo G308-33: Wide Crack

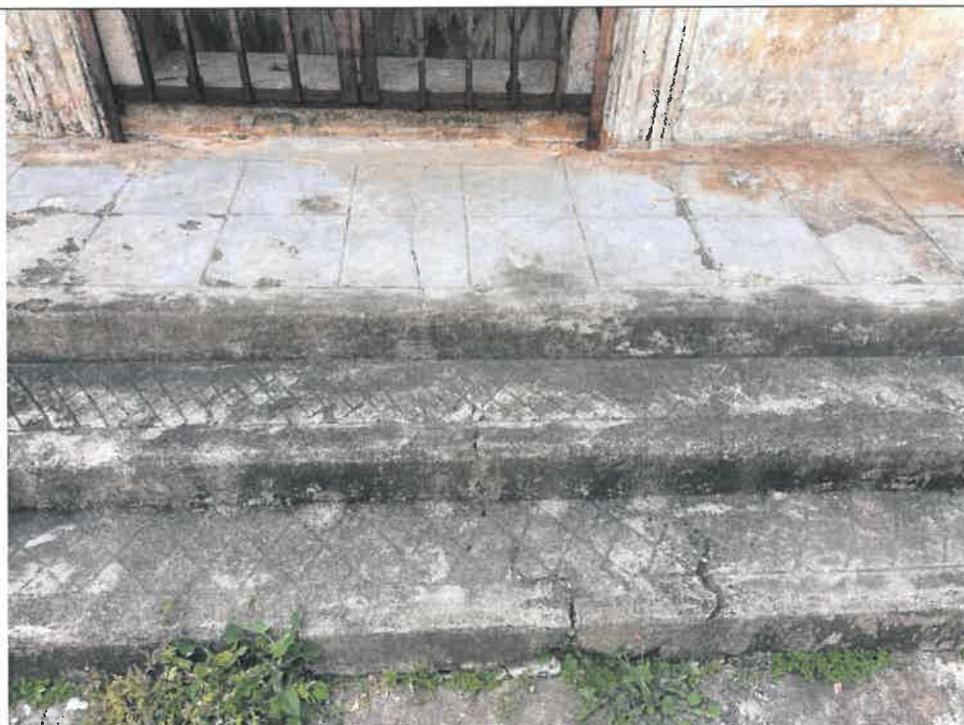
Photo G308-34: Wide Crack

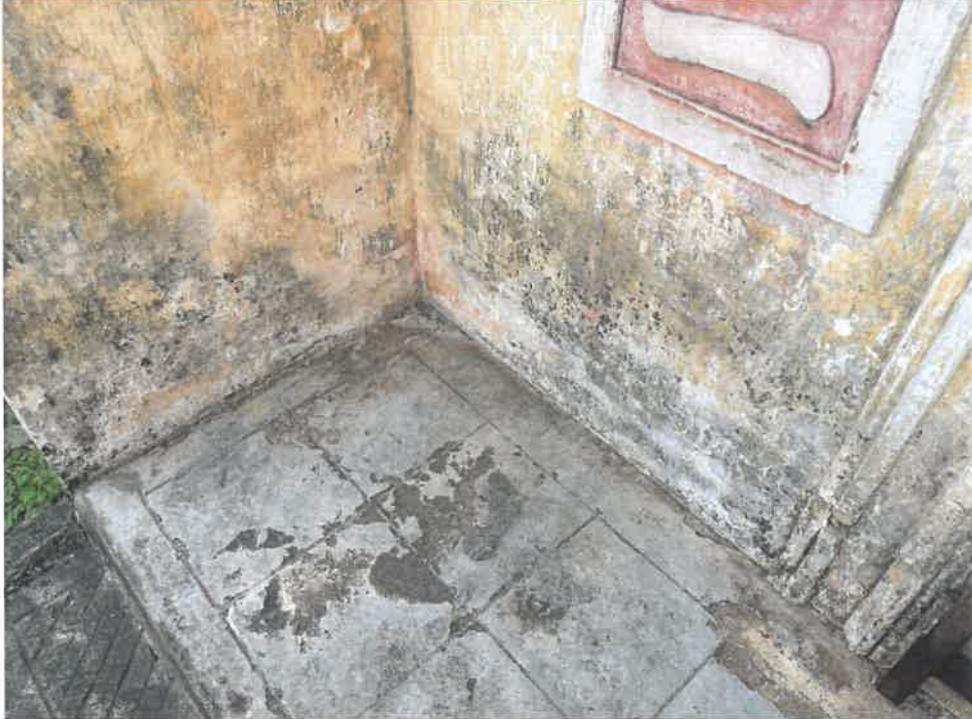
Photo G308-35: Moderate Crack

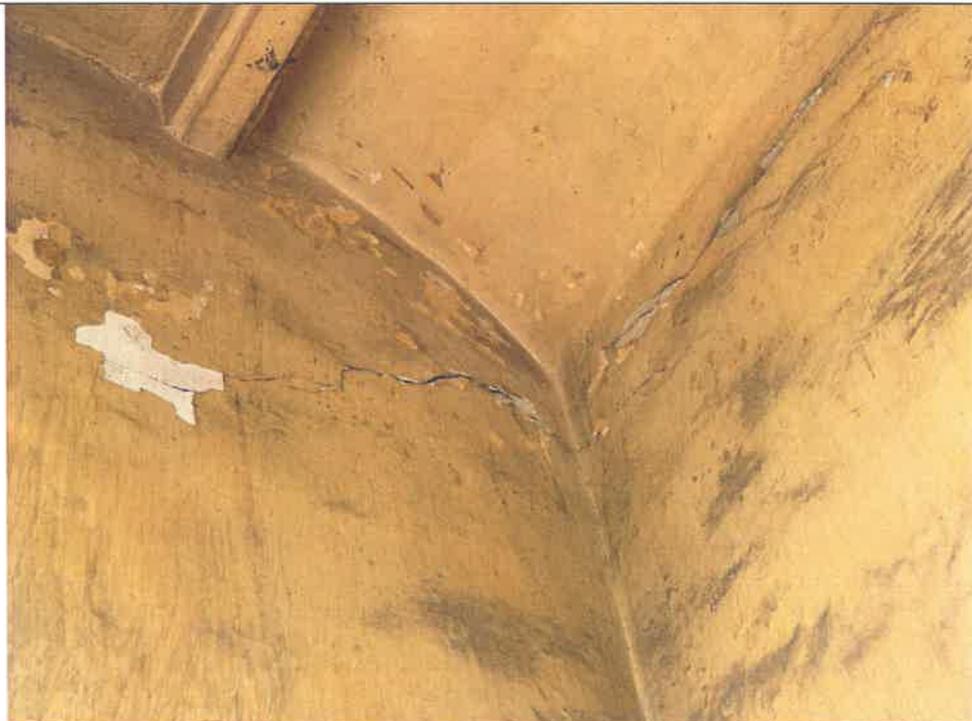
Photo G308-36: Moderate Crack on Surface

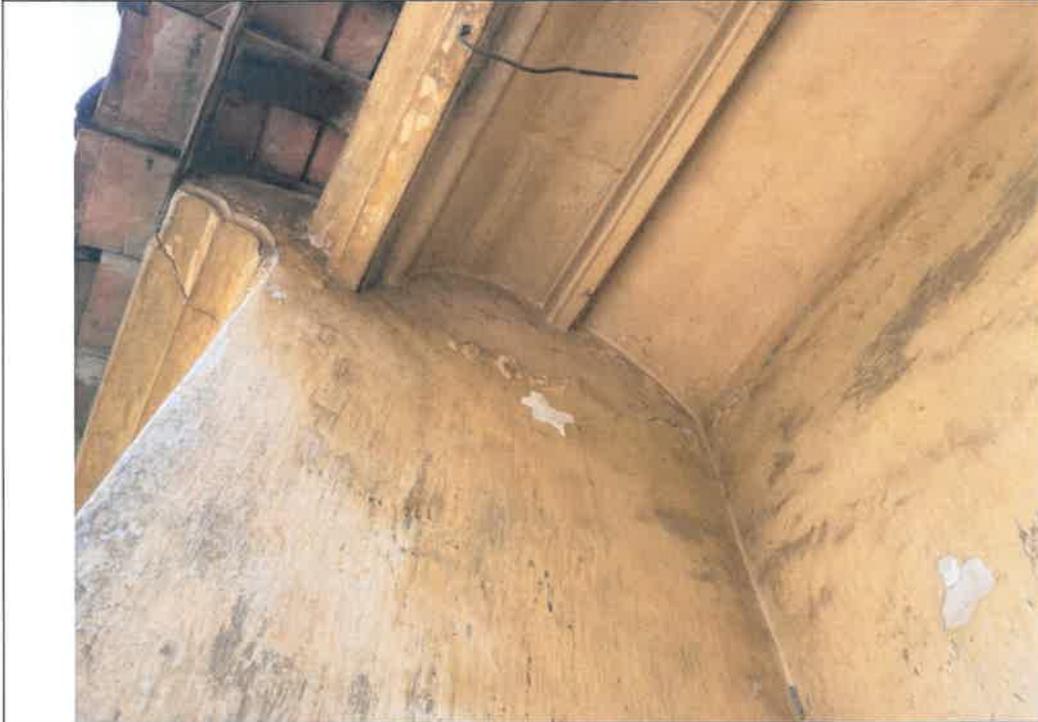
Photo G308-37: Moderate Crack

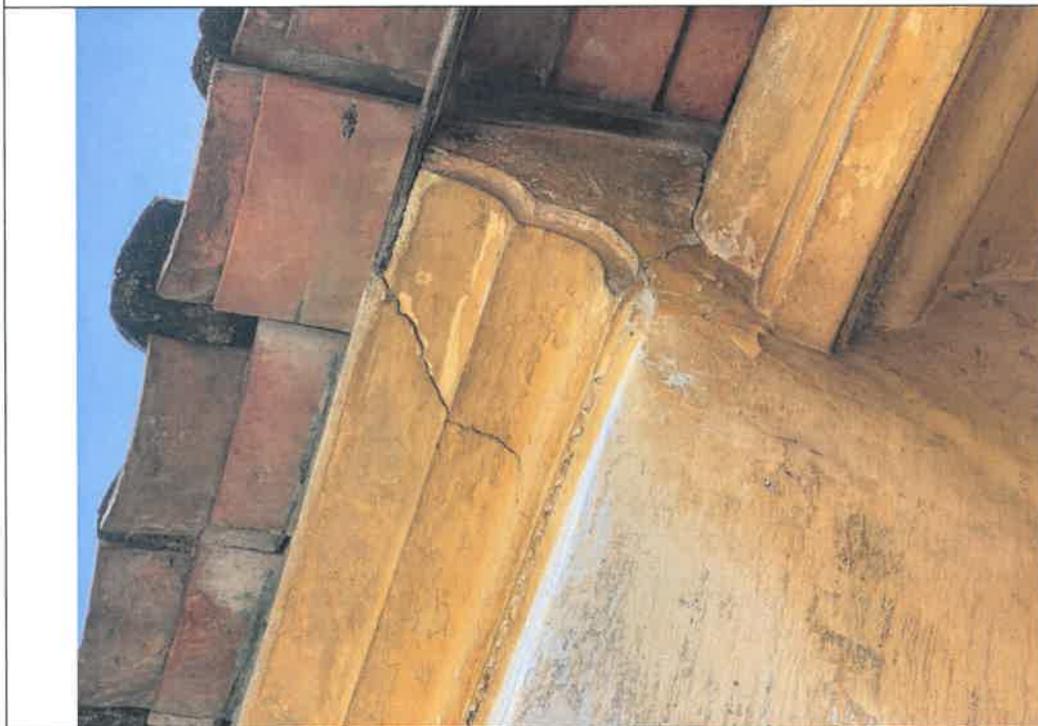
Photo G308-38: Wide Crack

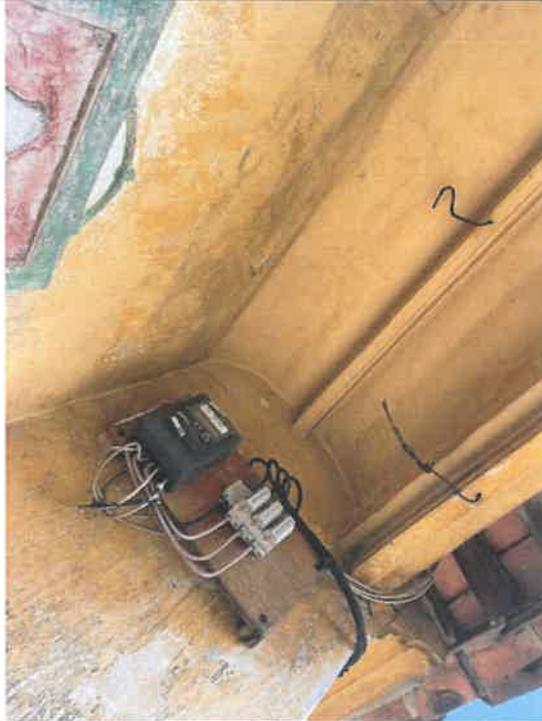
Photo G308-39: Fine Crack

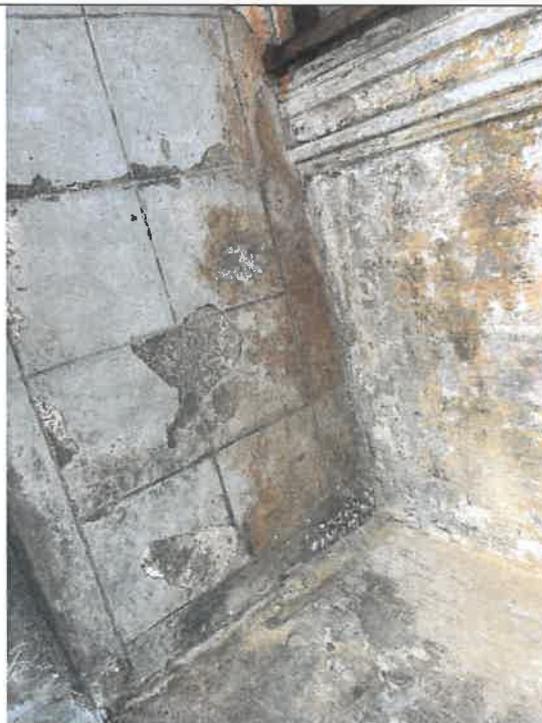
Photo G308-40: Wide Crack

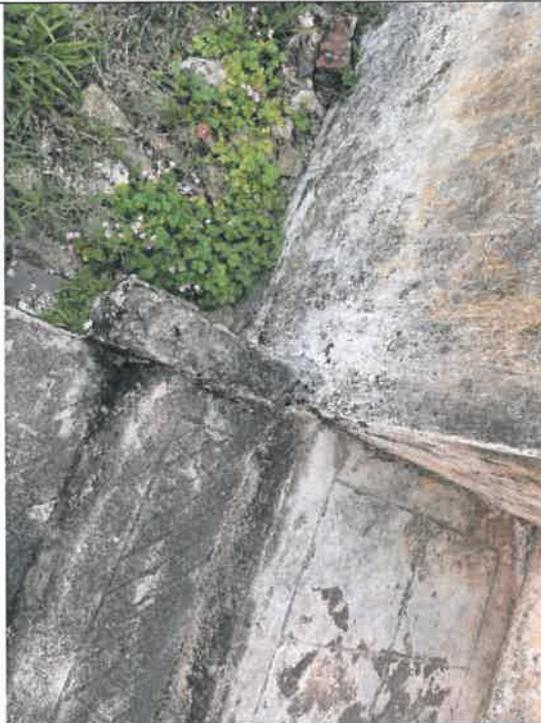
Photo G308-41: Fine Crack

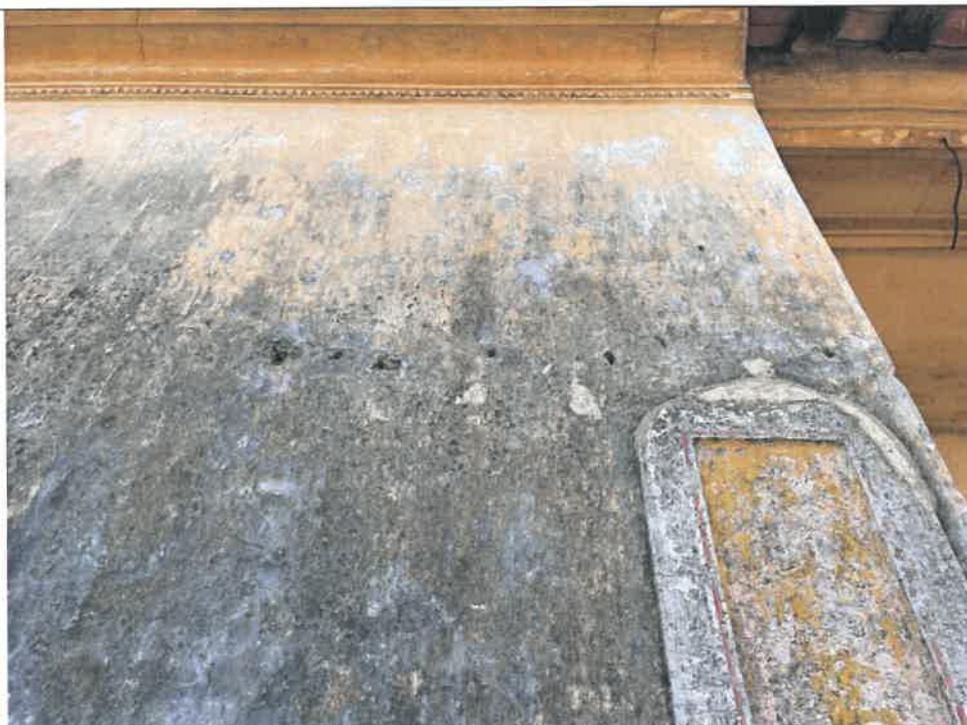
Photo G308-42: Moderate Crack

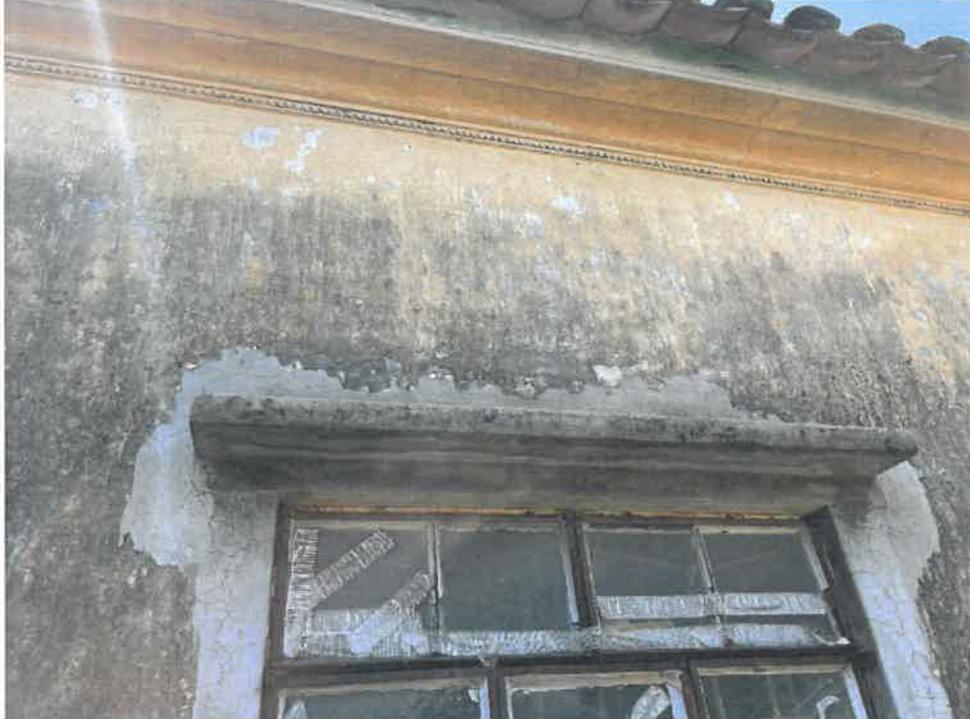
Photo G308-43: Moderate Crack

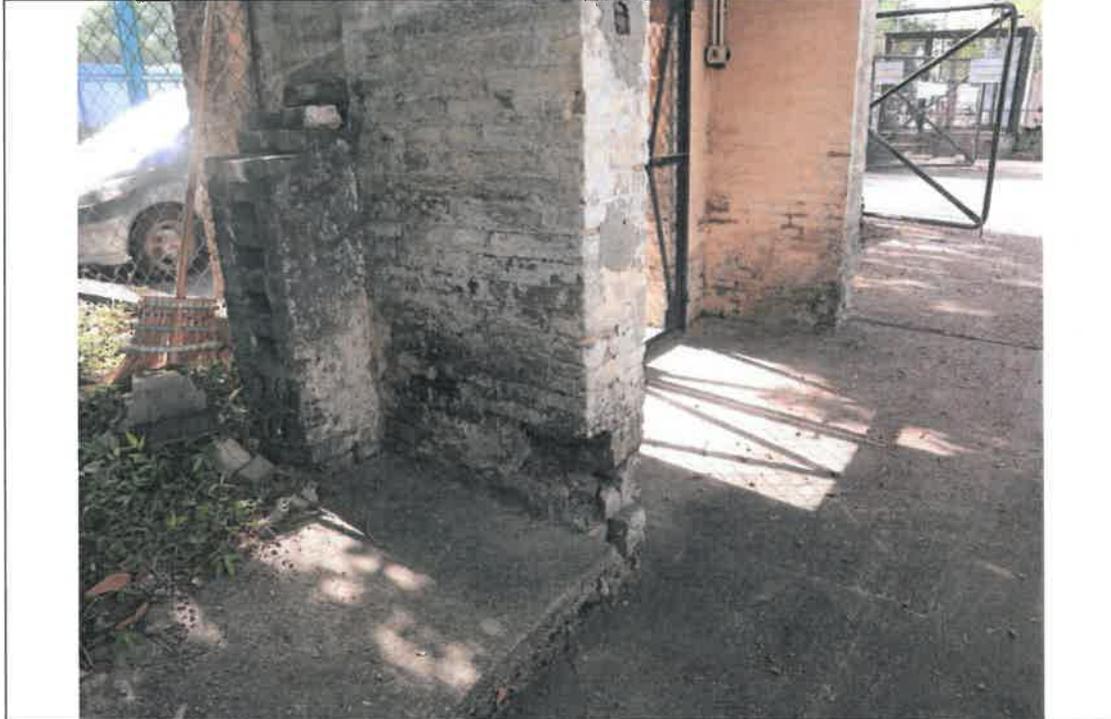
Photo 1- EG-9: Missing bricks on the structure

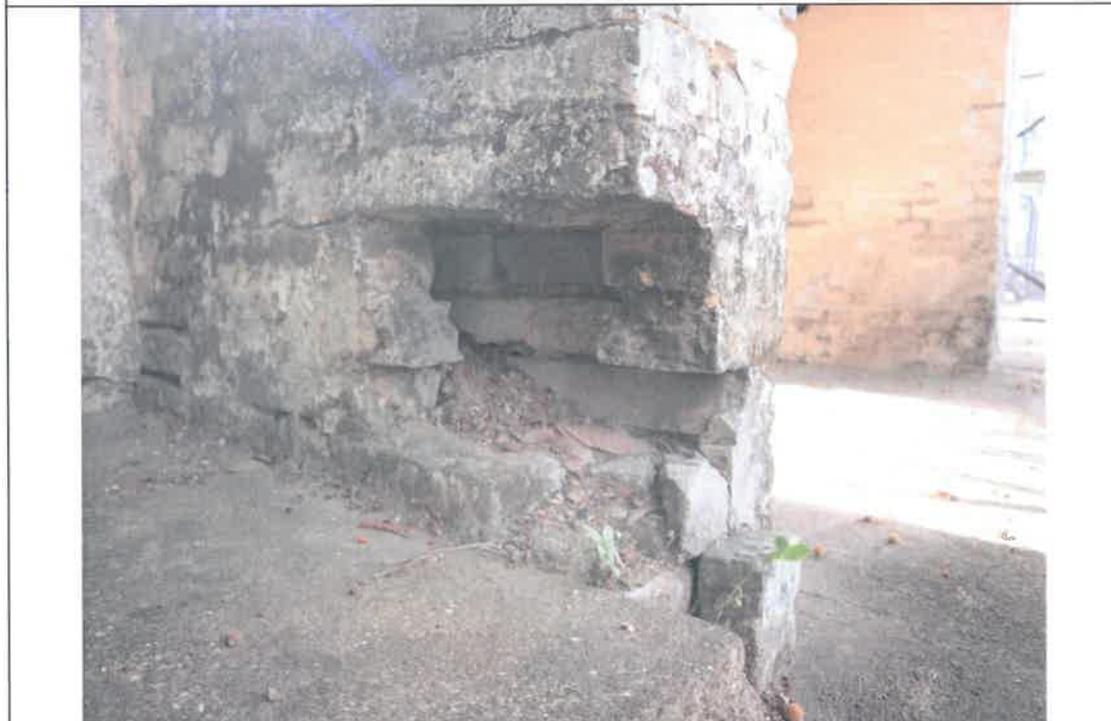
Photo 1-EG-10 Missing bricks on the structure

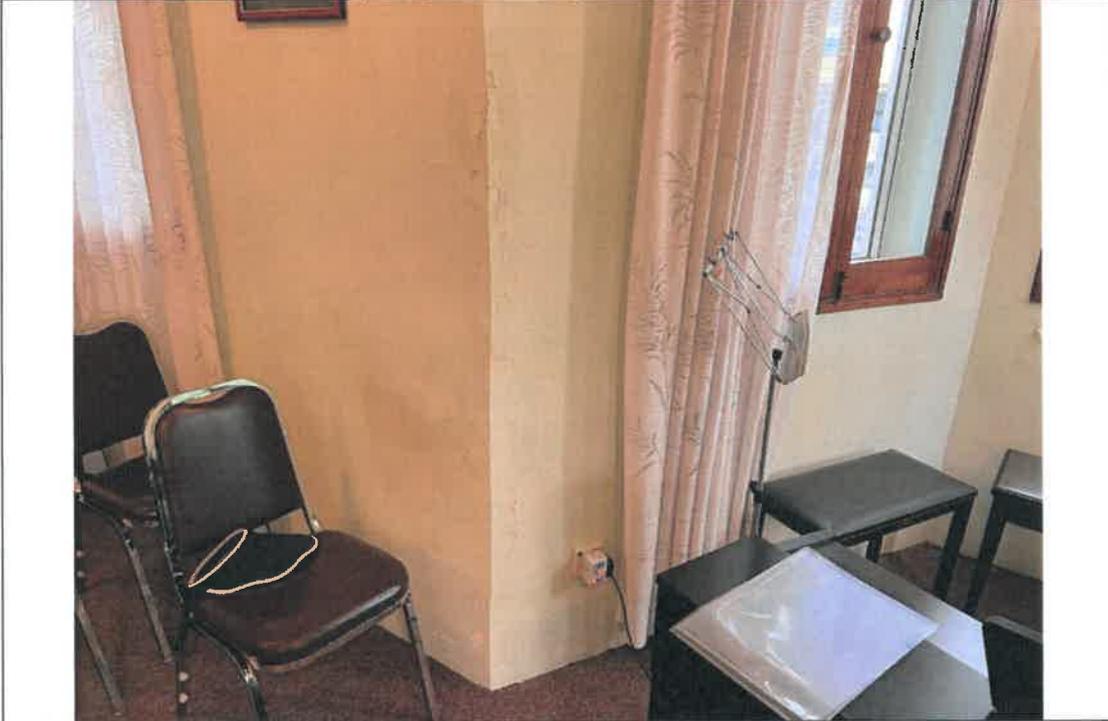
Photo: HKT03-23 Peel off paint with moisture

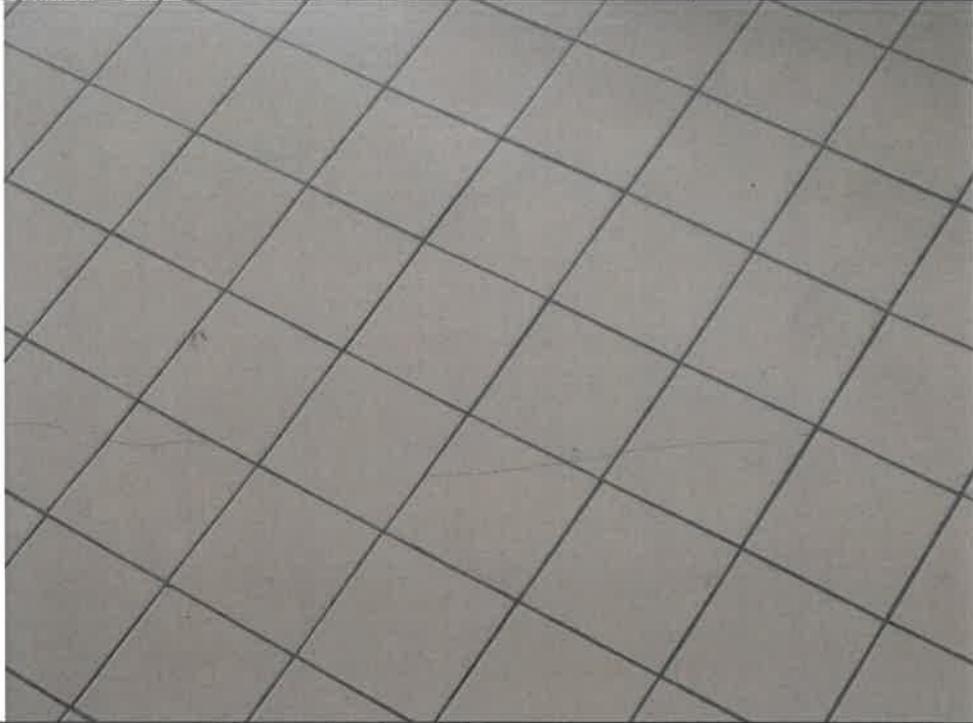
Photo: HKT03-33 Crack on floor tiles
