**Contract No. ND/2019/02**

**Kwu Tung North New Development Area, Phase 1:  
Road and Drains between Kwu Tung North New  
Development Area and Shek Wu Hui**

**Baseline Condition Survey and  
Baseline Vibration Impact Assessment Report**

Rev. 7

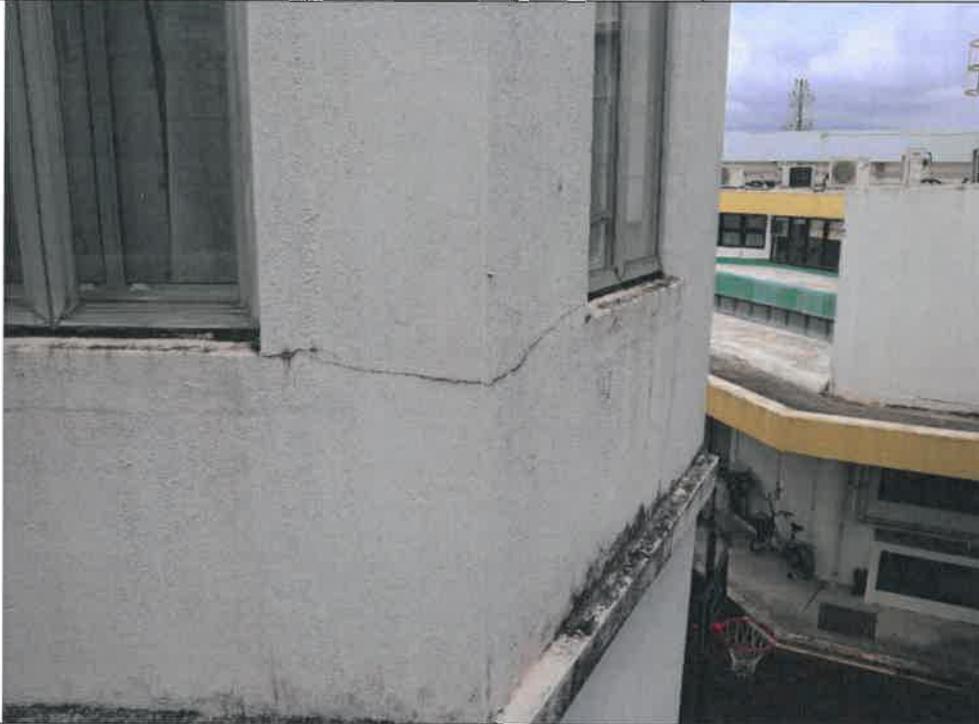
Photo: HKT03-51 Moderate cracks on surface

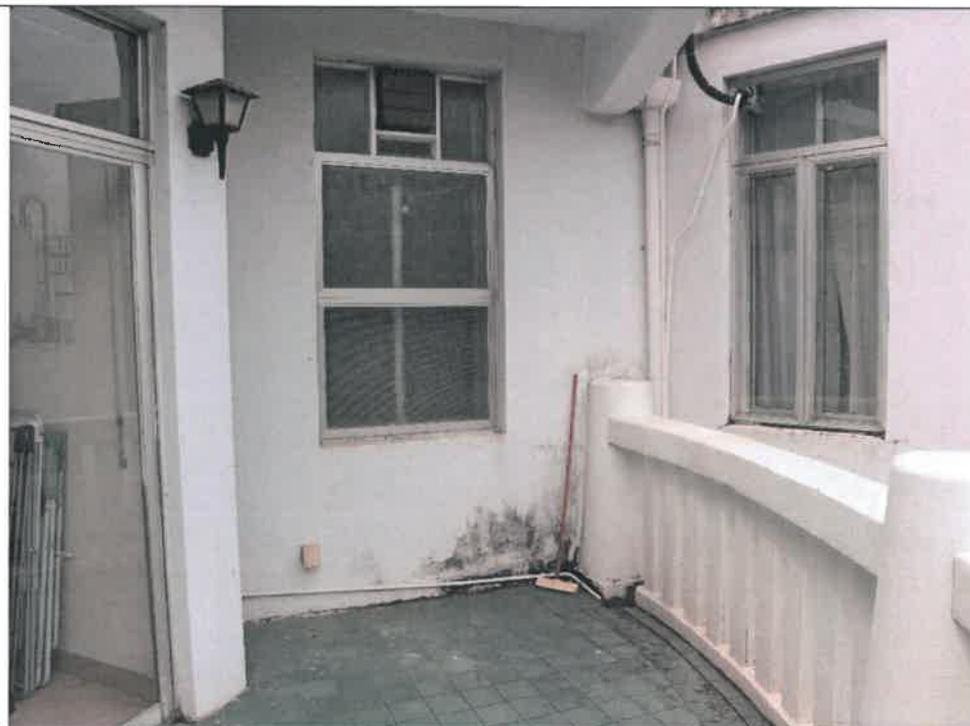
Photo: HKT03-52 Fine cracks on surface

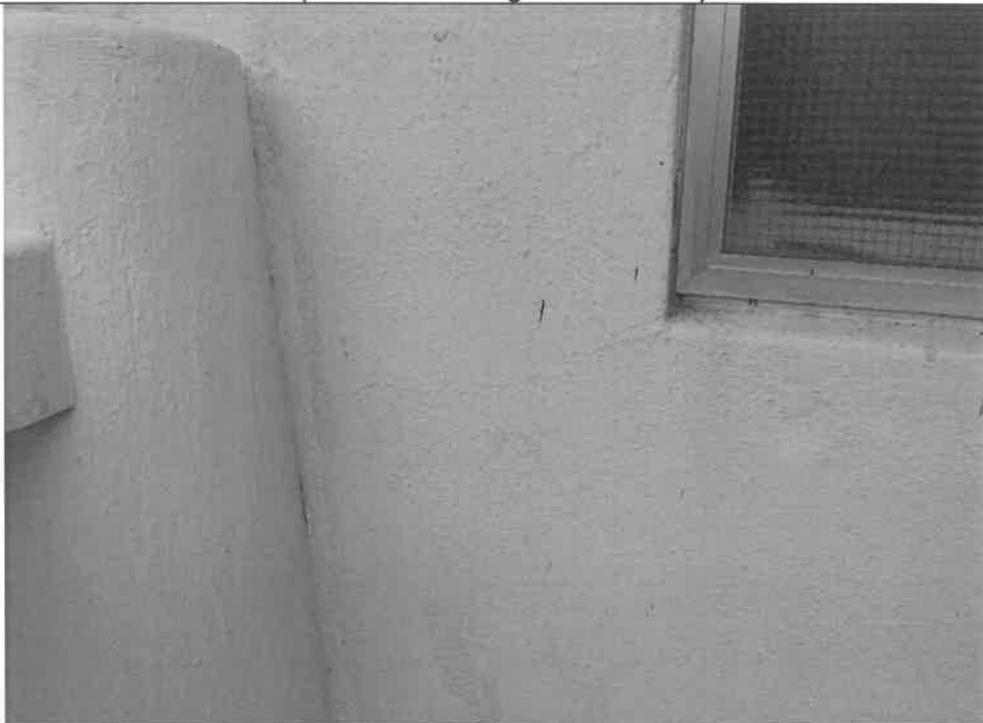
Photo: HKT03-53 Fine cracks on surface
